# Access Compliance Report Public Rights-of-Way (Curb Ramps)

Main Street: **MERCANTILE\_WAY** Cross Street: **SECOND\_ST** Location: **NE**

ADA ID: **RPRK211029124718** Ramp Type: **Type 4 - Parallel** Initial Pass/Fail: **Fail** Overall Compliance: **No** Severity Score: **16**

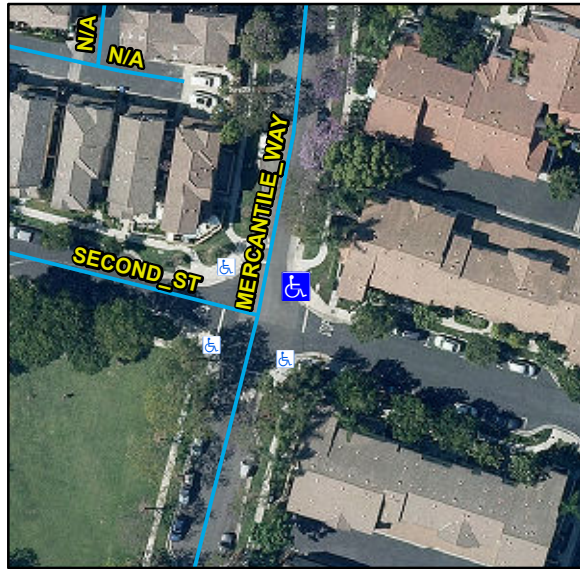
| Compliance | Description | Data | Compliance | Description | Data |
|---|---|---|---|---|---|
| <b>No</b> | Ramp Run Slope LT (%) | <b>9.4</b> | <b>Yes</b> | Ramp Run Slope RT (%) | <b>1.2</b> |
| <b>No</b> | Ramp Cross Slope LT (%) | <b>4.8</b> | <b>No</b> | Ramp Cross Slope RT (%) | <b>2.1</b> |

**Remove & Replace Curb Ramp With Two New Directional Ramps or Equivalent.**
