# Access Compliance Report Public Rights-of-Way (Curb Ramps)

Main Street: MAIN\_ST Cross Street: THIRD\_RD Location: E

ADA ID: RPRK211029125555 Ramp Type: Type 4 - Parallel Initial Pass/Fail: Fail Overall Compliance: No Severity Score: 2

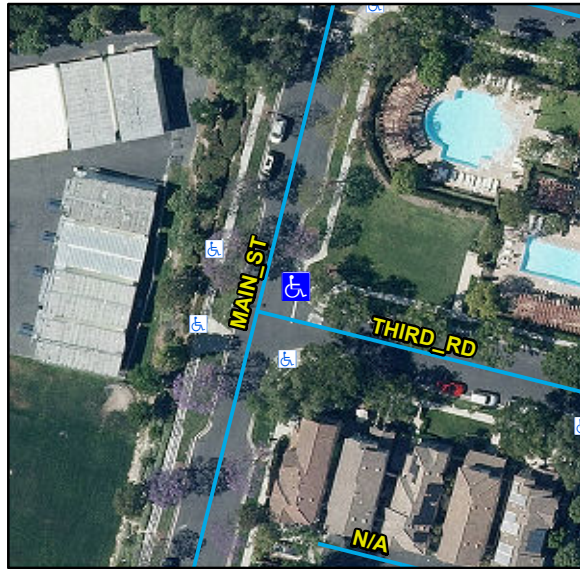
| Compliance | Description | Data | Compliance | Description | Data |
|---|---|---|---|---|---|
| No | Ramp Cross Slope LT (%) | 3.9 | No | Ramp Cross Slope RT (%) | 3.4 |

**Remove & Replace Curb Ramp With Two New Directional Ramps or Equivalent.**

**R204.3, R304.5.3, STD 1115**
