# Access Compliance Report Public Rights-of-Way (Curb Ramps)

Main Street: THIRD\_RD Cross Street: MAIN\_ST Location: S

ADA ID: RPRK211029125915 Ramp Type: Type 4 - Parallel Initial Pass/Fail: Fail Overall Compliance: No Severity Score: 2

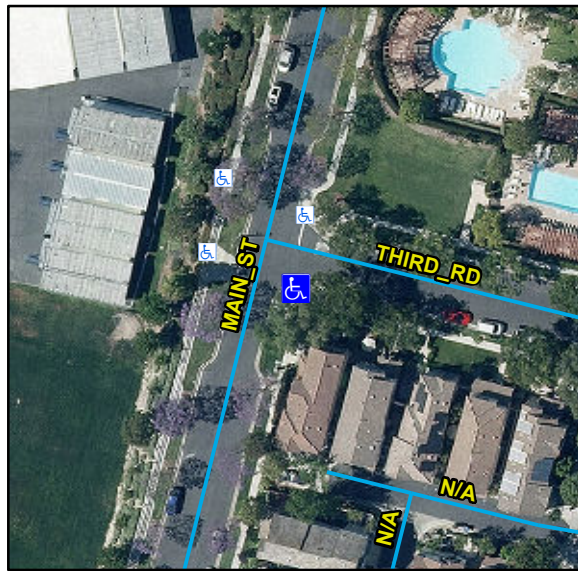
| Compliance | Description | Data | Compliance | Description | Data |
|---|---|---|---|---|---|
| No | Ramp Cross Slope LT (%) | 3.1 | No | Ramp Cross Slope RT (%) | 4.2 |

Remove & Replace Curb Ramp With Two New Directional Ramps or Equivalent.

R204.3, R304.5.3, STD 1115
