# Access Compliance Report Public Rights-of-Way (Curb Ramps)

Main Street: MAIN\_ST Cross Street: THIRD\_RD Location: W

ADA ID: RPRK211029130250 Ramp Type: Type 1 - Perpendicular Initial Pass/Fail: Pass Overall Compliance: No Severity Score: 16

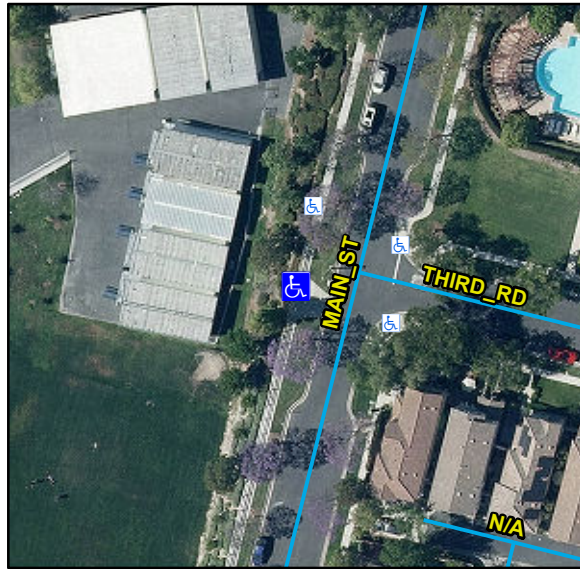
| Compliance | Description | Data | Compliance | Description | Data |
|---|---|---|---|---|---|
| No | Landing Run Slope (%) | 2.3 | N/A | Flare Traversable RT | No |
| Yes | Landing Cross Slope (%) | 1.7 | No | DWS Provided | No |
| Yes | Gutter Ponding | No | No | Curb Slope | 8.1 |
| No | Gutter Run Slope (%) | 13 | | Road Cross Slope (%) | N/A |

Remove & Replace Entire Ramp. Remove & Replace Gutter.
