# Access Compliance Report Public Rights-of-Way (Curb Ramps)

Main Street: MAIN\_ST Cross Street: N/A Location: E

ADA ID: RPRK211029131049 Ramp Type: Type 4 - Parallel Initial Pass/Fail: Pass Overall Compliance: No Severity Score: 26

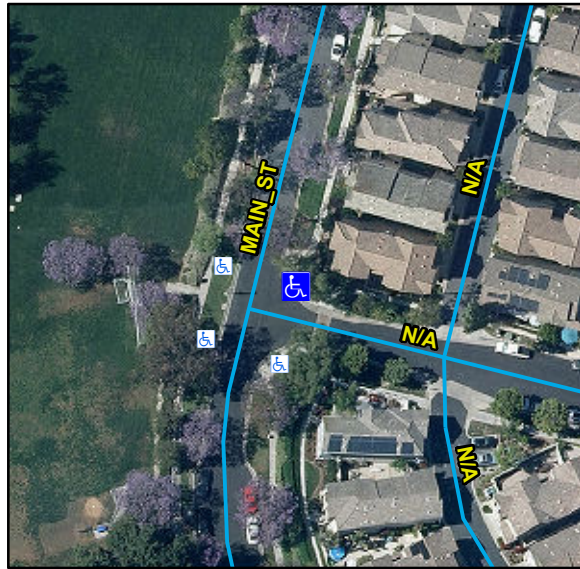
| Compliance | Description | Data | Compliance | Description | Data |
|---|---|---|---|---|---|
| No | Ramp Cross Slope LT (%) | 2.5 | No | Ramp Cross Slope RT (%) | 2.7 |
| N/A | Landing Present | No | No | DWS Provided | No |
| No | Gutter Run Slope (%) | 7.6 | | Road Cross Slope (%) | 0.3 |
| No | Gutter Cross Slope (%) | 3.2 | No | Perpendicular Joint Present | No |

Remove & Replace Curb Ramp With Two New Directional Ramps or Equivalent. Remove & Replace Gutter.
