# Access Compliance Report Public Rights-of-Way (Curb Ramps)

Main Street: MAIN\_ST Cross Street: N/A Location: S

ADA ID: RPRK211029131701 Ramp Type: Type 4 - Parallel Initial Pass/Fail: Fail Overall Compliance: No Severity Score: 30

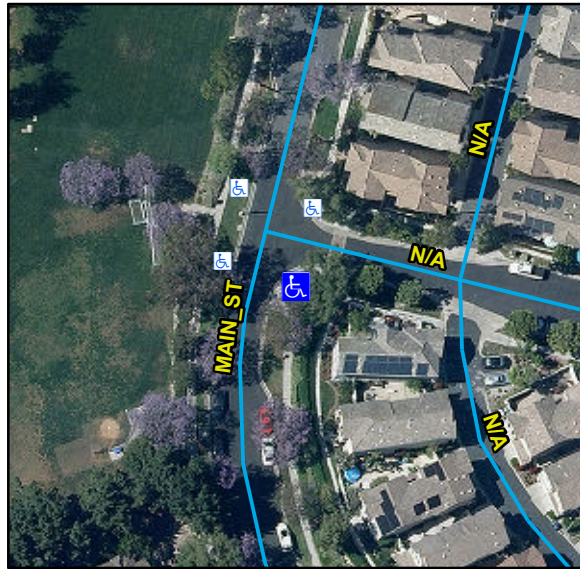
| Compliance | Description | Data | Compliance | Description | Data |
|---|---|---|---|---|---|
| No | Ramp Cross Slope LT (%) | 10 | No | Ramp Cross Slope RT (%) | 7.2 |

Remove & Replace Curb Ramp With Two New Directional Ramps or Equivalent.
