# Access Compliance Report Public Rights-of-Way (Curb Ramps)

| Main Street: WINDMILL_AVE | | Cross Street: MAIN_ST | | Location: | SW |
| ADA ID: RPRK211029133829 | Ramp Type:Type 1 - Perpendicular | Initial Pass/Fail: Pass | Overall Compliance: No | Severity Score: | 25 |

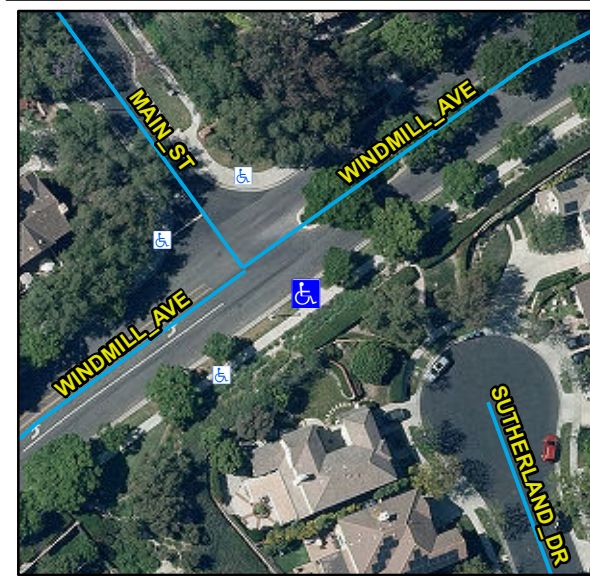
| Compliance | Description | Data | Compliance | Description | Data |
|---|---|---|---|---|---|
| No | Landing Width (in) | N/A | N/A | Flare Slope RT (%) | 17.3 |
| No | Landing Run Slope (%) | N/A | N/A | Flare Traversable RT | No |
| No | Landing Cross Slope (%) | N/A | No | DWS Provided | No |
| Yes | Gutter Ponding | No | No | Curb Slope | 9 |
| No | Gutter Run Slope (%) | 6.6 | | Road Cross Slope (%) | N/A |

Remove & Replace Entire Ramp. Remove & Replace Gutter.
