# Access Compliance Report Public Rights-of-Way (Curb Ramps)

Main Street: WINDMILL\_AVE Cross Street: ANTONIO\_PKWY Location: N

ADA ID: RPRK211029140012 Ramp Type: Type 1 - Perpendicular Diagonal Initial Pass/Fail: Fail Overall Compliance: No Severity Score: 2

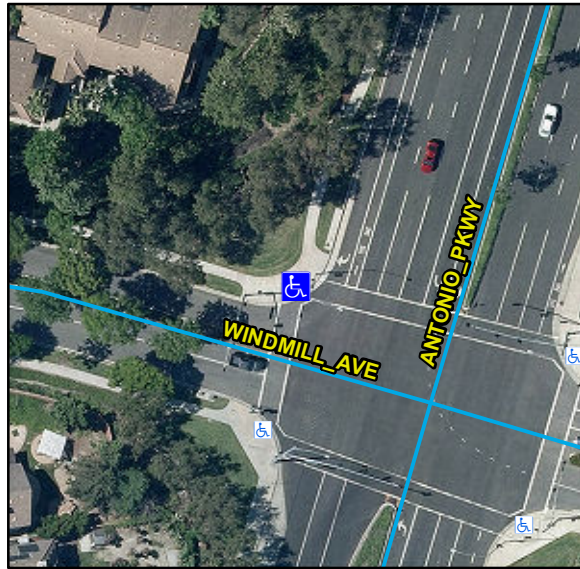
| Compliance | Description | Data | Compliance | Description | Data |
|---|---|---|---|---|---|
| No | Ramp Cross Slope (%) | 3.4 | N/A | Flare Traversable LT | N/A |
| N/A | Gutter Ponding | N/A | No | Curb Slope | 10.2 |

Remove & Replace Curb Ramp With Two New Directional Ramps or Equivalent.

R304.2.2, R204.3, R304.5.3, STD 1115
