# Access Compliance Report Public Rights-of-Way (Curb Ramps)

Main Street: ANTONIO\_PKWY Cross Street: WINDMILL\_AVE Location: W

ADA ID: RPRK211029140722 Ramp Type: Type 1 - Perpendicular Diagonal Initial Pass/Fail: Fail Overall Compliance: No Severity Score: 2

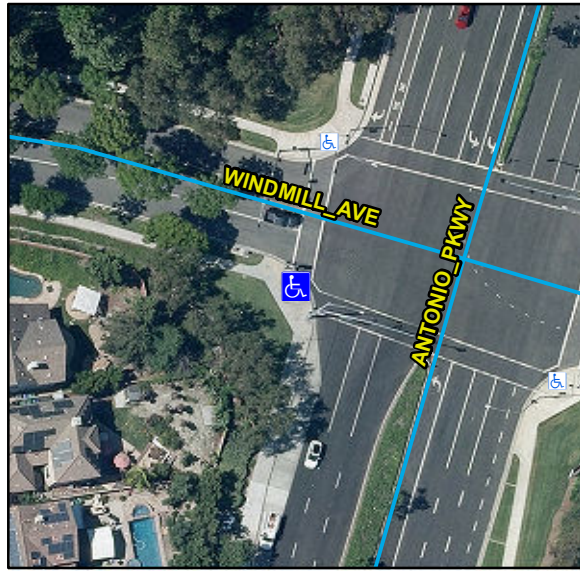
| Compliance | Description | Data | Compliance | Description | Data |
|---|---|---|---|---|---|
| No | Ramp Cross Slope (%) | 3.7 | N/A | Flare Traversable LT | N/A |

Remove & Replace Curb Ramp With Two New Directional Ramps or Equivalent.

R304.2.2, R204.3, R304.5.3, STD 1115
