# Access Compliance Report Public Rights-of-Way (Curb Ramps)

Main Street: WINDMILL\_AVE Cross Street: ANTONIO\_PKWY Location: S

ADA ID: RPRK211029141456 Ramp Type: Type 1 - Perpendicular Diagonal Initial Pass/Fail: Fail Overall Compliance: No Severity Score: 0

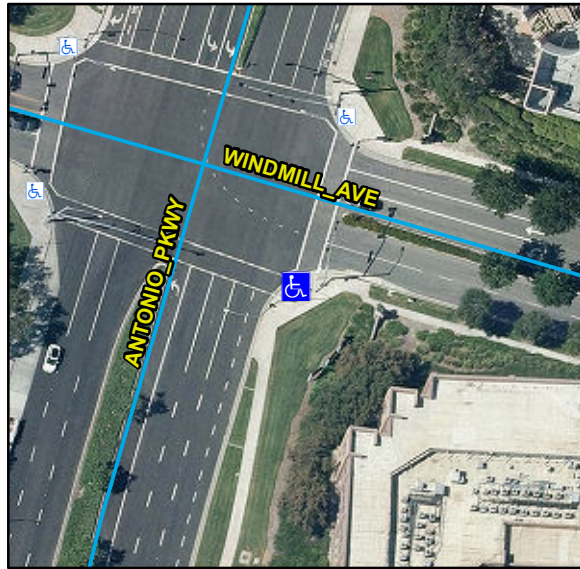
| Compliance | Description | Data | Compliance | Description | Data |
|---|---|---|---|---|---|
| N/A | Gutter Ponding | N/A | No | Curb Slope | 9.3 |
| Yes | Overall Surface Condition: Acceptable | | No | Perp Joint Present | No |

Remove & Replace Curb Ramp With Two New Directional Ramps or Equivalent.

R304.2.2, R204.3, STD 1115
