# Access Compliance Report Public Rights-of-Way (Curb Ramps)

Main Street: ANTONIO\_PKWY Cross Street: WINDMILL\_AVE Location: E

ADA ID: RPRK211029142026 Ramp Type: Type 1 - Perpendicular Diagonal Initial Pass/Fail: Pass Overall Compliance: No Severity Score: 10

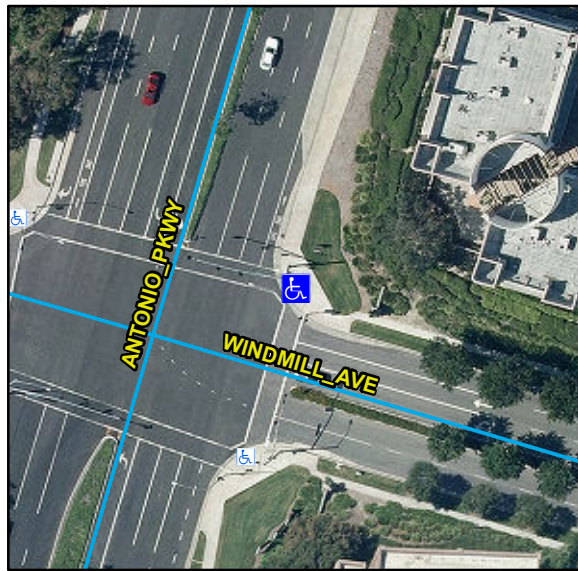
| Compliance | Description | Data | Compliance | Description | Data |
|---|---|---|---|---|---|
| No | Landing Run Slope (%) | 2.3 | N/A | Flare Traversable RT | Yes |
| Yes | Landing Cross Slope (%) | 1.3 | No | DWS Provided | No |
| Yes | Gutter Ponding | No | No | Curb Slope | 8.6 |

Remove & Replace Curb Ramp With Two New Directional Ramps or Equivalent.
