# Access Compliance Report Public Rights-of-Way (Curb Ramps)

Main Street: SNAPDRAGON\_ST Cross Street: WINDMILL\_AVE Location: SW

ADA ID: RPRK211029143529 Ramp Type: Type 4 - Parallel Initial Pass/Fail: Fail Overall Compliance: No Severity Score: 15

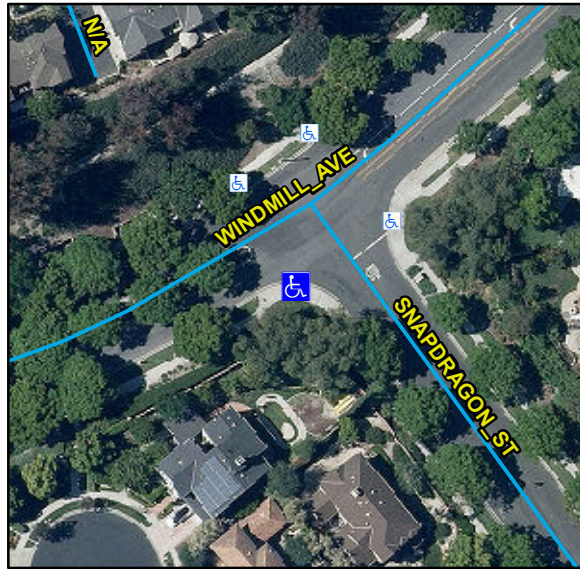
| Compliance | Description | Data | Compliance | Description | Data |
|---|---|---|---|---|---|
| No | Ramp Cross Slope LT (%) | 5.4 | No | Ramp Cross Slope RT (%) | 4.4 |

Remove & Replace Curb Ramp With Two New Directional Ramps or Equivalent.

R204.3, R304.5.3, STD 1115
