# Access Compliance Report Public Rights-of-Way (Curb Ramps)

| Main Street: WINDMILL_AVE | | Cross Street: SNAPDRAGON_ST | | Location: | N |
| ADA ID: RPRK211029143901 | Ramp Type: Type 4 - Parallel | Initial Pass/Fail: Fail | Overall Compliance: No | Severity Score: | 30 |

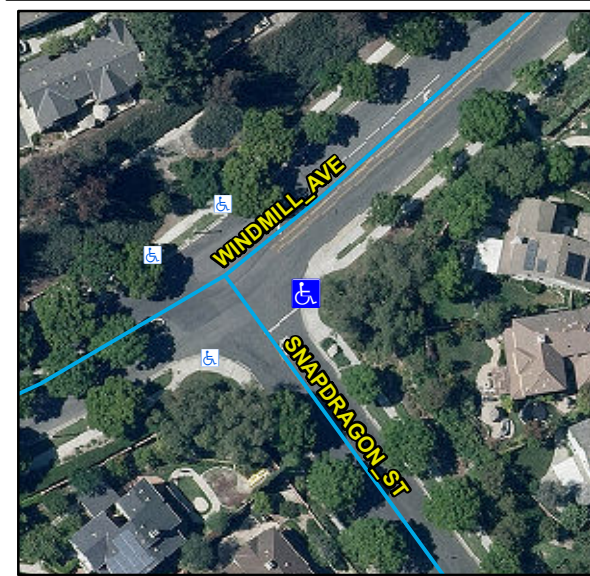
| Compliance | Description | Data | Compliance | Description | Data |
|---|---|---|---|---|---|
| No | Ramp Run Slope LT (%) | 10 | Yes | Ramp Run Slope RT (%) | 5.5 |
| No | Ramp Cross Slope LT (%) | 3 | No | Ramp Cross Slope RT (%) | 6.5 |

Possible Solutions:

**Remove & Replace Curb Ramp With Two New Directional Ramps or Equivalent.**

**R204.3, R304.3.2, R304.5.3, STD 1115**

Total Cost: \$ 4000
