# Access Compliance Report Public Rights-of-Way (Curb Ramps)

Main Street: SNAPDRAGON\_ST Cross Street: STERLING\_GLEN Location: NE

ADA ID: RPRK211029144350 Ramp Type: Type 4 - Parallel Initial Pass/Fail: Fail Overall Compliance: No Severity Score: 16

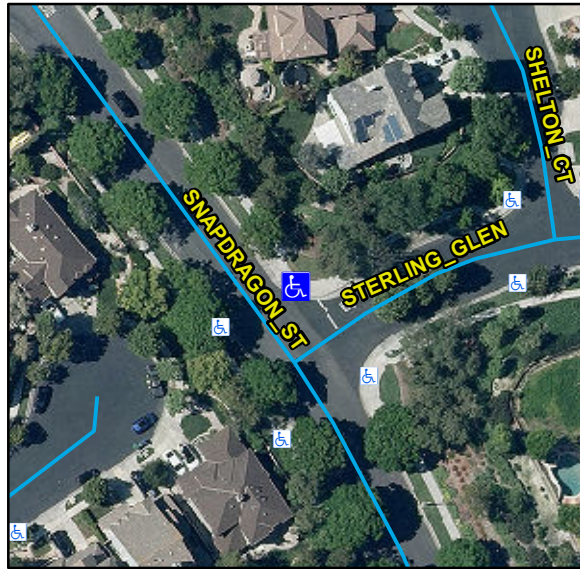
| Compliance | Description | Data | Compliance | Description | Data |
|---|---|---|---|---|---|
| No | Ramp Run Slope LT (%) | 9.8 | Yes | Ramp Run Slope RT (%) | 4.2 |
| N/A | Gutter Cross Slope (%) | N/A | No | Perpendicular Joint Present | No |

Remove & Replace Curb Ramp With Two New Directional Ramps or Equivalent.

R204.3, R304.3.2, STD 1115
