# Access Compliance Report Public Rights-of-Way (Curb Ramps)

Main Street: STERLING\_GLEN Cross Street: SNAPDRAGON\_ST Location: SE

ADA ID: RPRK211029144749 Ramp Type: Type 4 - Parallel Initial Pass/Fail: Fail Overall Compliance: No Severity Score: 16

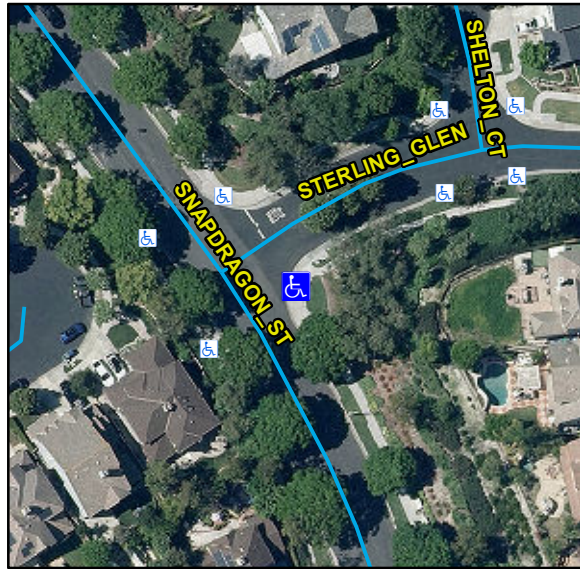
| Compliance | Description | Data | Compliance | Description | Data |
|---|---|---|---|---|---|
| No | Ramp Run Slope LT (%) | 8.4 | Yes | Ramp Run Slope RT (%) | 0.2 |
| Yes | Ramp Cross Slope LT (%) | 0.2 | No | Ramp Cross Slope RT (%) | 2.5 |

Remove & Replace Curb Ramp With Two New Directional Ramps or Equivalent.
