# Access Compliance Report Public Rights-of-Way (Curb Ramps)

Main Street: CROWN\_VALLEY\_PKWY Cross Street: ANTONIO\_PKWY Location: SE

ADA ID: RPRK211101111754 Ramp Type: Type 1 - Perpendicular Diagonal Initial Pass/Fail: Pass Overall Compliance: No Severity Score: 16

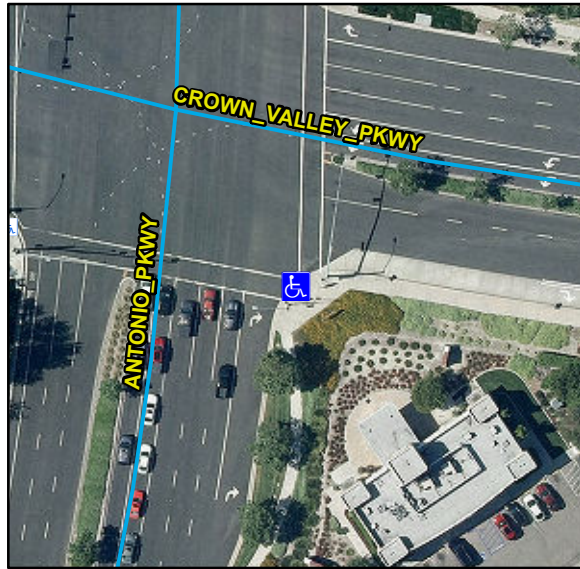
| Compliance | Description | Data | Compliance | Description | Data |
|---|---|---|---|---|---|
| No | Landing Run Slope (%) | 2.5 | N/A | Flare Traversable RT | No |
| Yes | Landing Cross Slope (%) | 3.2 | No | DWS Provided | No |
| Yes | Gutter Ponding | No | No | Curb Slope | 10.7 |
| No | Gutter Run Slope (%) | 11.1 | | Road Cross Slope (%) | 2.2 |

Remove & Replace Curb Ramp With Two New Directional Ramps or Equivalent. Remove & Replace Gutter.
