# Access Compliance Report Public Rights-of-Way (Curb Ramps)

Main Street: ANTONIO\_PKWY Cross Street: CROWN\_VALLEY\_PKWY Location: NE

ADA ID: RPRK211101112432 Ramp Type: Type 1 - Perpendicular Diagonal Initial Pass/Fail: Pass Overall Compliance: No Severity Score: 16

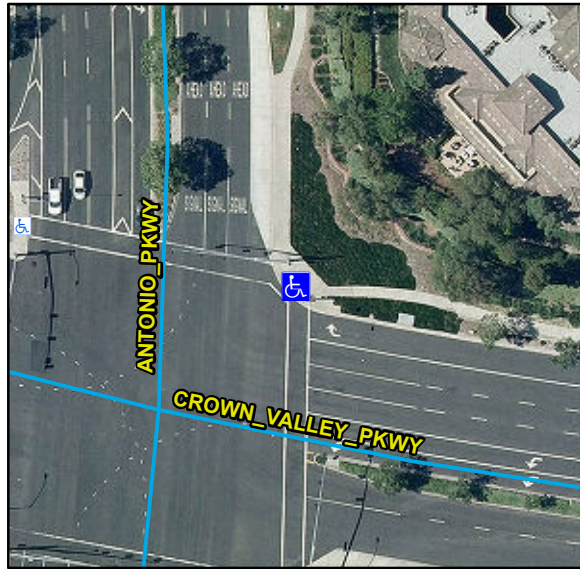
| Compliance | Description | Data | Compliance | Description | Data |
|---|---|---|---|---|---|
| Yes | Landing Cross Slope (%) | 0.4 | No | DWS Provided | No |
| No | Gutter Run Slope (%) | 12.8 | | Road Cross Slope (%) | 1.7 |

Install Detectable Warning System. Remove & Replace Gutter.

R305, R304.5.4, STD 1115
