# Access Compliance Report Public Rights-of-Way (Curb Ramps)

Main Street: CROWN\_VALLEY\_PKWY Cross Street: ANTONIO\_PKWY Location: NW

ADA ID: RPRK211101112856 Ramp Type: Type 4 - Parallel Initial Pass/Fail: Pass Overall Compliance: No Severity Score: 30

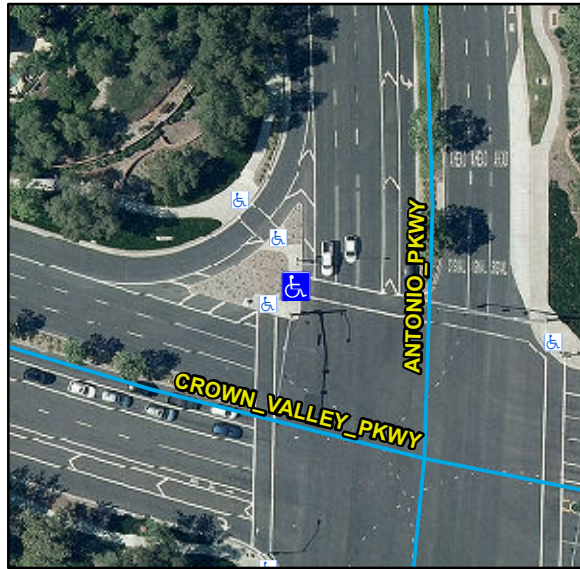
| Compliance | Description | Data | Compliance | Description | Data |
|---|---|---|---|---|---|
| Yes | Ramp Run Slope LT (%) | 4.9 | No | Ramp Run Slope RT (%) | 9.2 |
| N/A | Landing Present | Yes | No | DWS Provided | No |
| No | Gutter Ponding | Yes | N/A | Curb Slope | 1.7 |
| No | Gutter Run Slope (%) | 11.4 | | Road Cross Slope (%) | N/A |
| No | Gutter Cross Slope (%) | 2.2 | No | Perpendicular Joint Present | No |

Remove & Replace Entire Ramp. Remove & Replace Gutter.
