# Access Compliance Report Public Rights-of-Way (Curb Ramps)

Main Street: CROWN\_VALLEY\_PKWY Cross Street: ANTONIO\_PKWY Location: NW

ADA ID: RPRK211101113247 Ramp Type: Type 1 - Perpendicular Initial Pass/Fail: Fail Overall Compliance: No Severity Score: 15

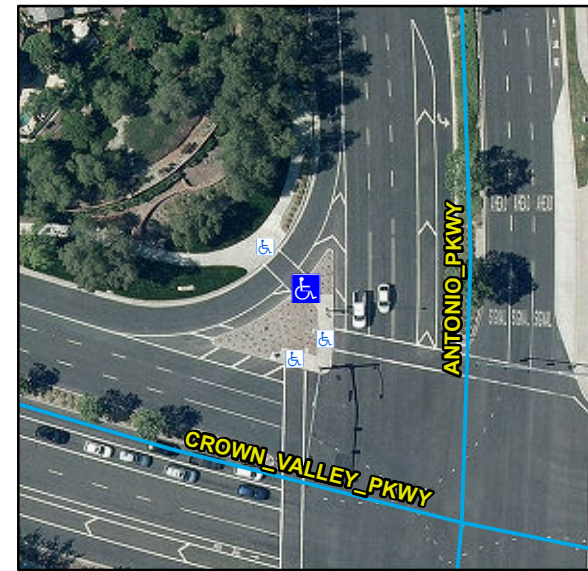
| Compliance | Description | Data | Compliance | Description | Data |
|---|---|---|---|---|---|
| No | Ramp Run Slope (%) | 8.7 | N/A | Flare Slope LT (%) | N/A |

Remove & Replace Entire Ramp.
