# Access Compliance Report Public Rights-of-Way (Curb Ramps)

Main Street: CROWN\_VALLEY\_PKWY Cross Street: ANTONIO\_PKWY Location: NW

ADA ID: RPRK211101113408 Ramp Type: Type 1 - Perpendicular Initial Pass/Fail: Fail Overall Compliance: No Severity Score: 16

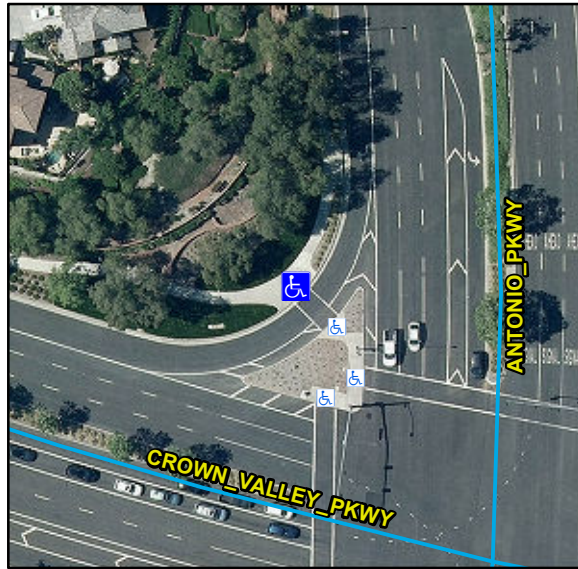
R204.3, R304.2.2, R304.5.3, STD 1115

| Compliance | Description | Data | Compliance | Description | Data |
|---|---|---|---|---|---|
| No | Ramp Run Slope (%) | 8.4 | N/A | Flare Slope LT (%) | N/A |
| No | Ramp Cross Slope (%) | 2.9 | N/A | Flare Traversable LT | N/A |

Remove & Replace Entire Ramp.
