# Access Compliance Report Public Rights-of-Way (Curb Ramps)

Main Street: CROWN\_VALLEY\_PKWY Cross Street: SIENNA\_PKWY Location: N

ADA ID: RPRK211101114146 Ramp Type: Type 1 - Perpendicular Diagonal Initial Pass/Fail: Fail Overall Compliance: No Severity Score: 15

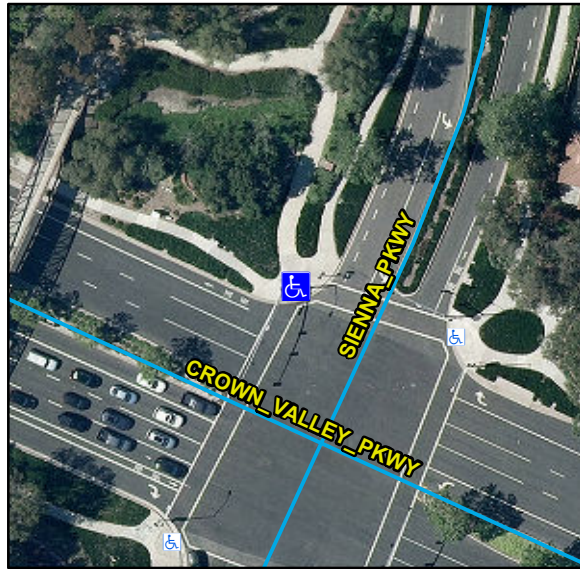
R304.2.2, R204.3, STD 1115

| Compliance | Description | Data | Compliance | Description | Data |
|---|---|---|---|---|---|
| No | Ramp Run Slope (%) | 10.7 | N/A | Flare Slope LT (%) | N/A |

Remove & Replace Curb Ramp With Two New Directional Ramps or Equivalent.
