# Access Compliance Report Public Rights-of-Way (Curb Ramps)

| Main Street: SIENNA_PKWY | | Cross Street: KYLE_CT | | Location: | SW |
| ADA ID: RPRK211101114409 | Ramp Type: Type 1 - Perpendicular | Initial Pass/Fail: Fail | Overall Compliance: No | Severity Score: | 2 |

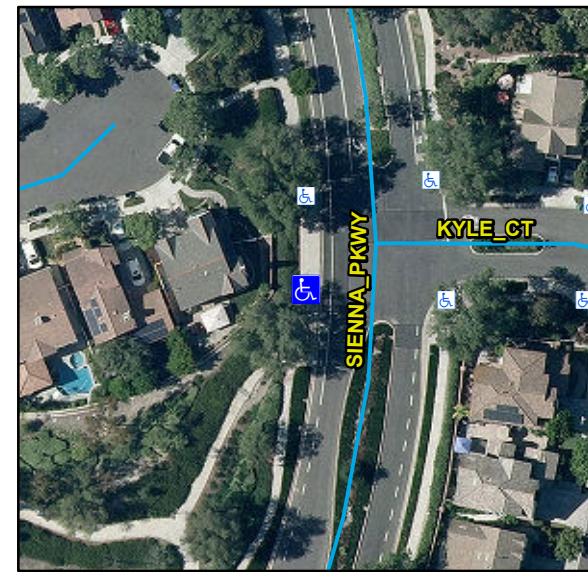
| Compliance | Description | Data | Compliance | Description | Data |
|---|---|---|---|---|---|
| No | Ramp Cross Slope (%) | 2.3 | N/A | Flare Traversable LT | N/A |
| N/A | Gutter Ponding | N/A | No | Curb Slope | 14.7 |

**Remove & Replace Entire Ramp.**

**R304.2.2, R204.3, R304.5.3, STD 1115**

Total Cost: \$ 3080

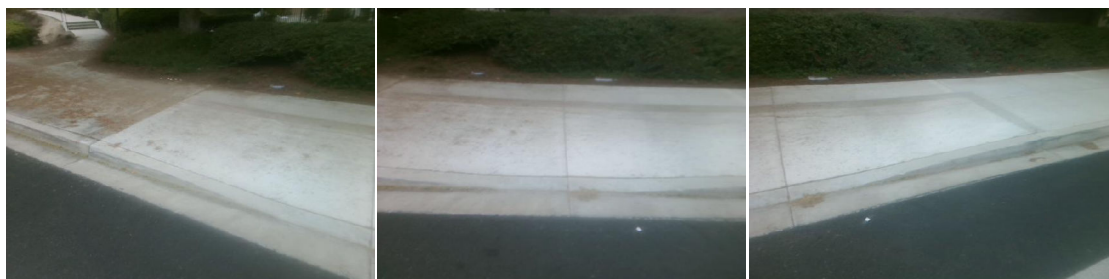
| Compliance | Description | Data | Compliance | Description | Data |
|---|---|---|---|---|---|
| N/A | Ramp Length (in) | 69 | N/A | Flare Type LT | |
| Yes | Ramp Width (in) | 48 | | | N/A |
| Yes | Ramp Run Slope (%) | 8.2 | N/A | Flare Slope LT (%) | N/A |
