# Access Compliance Report Public Rights-of-Way (Curb Ramps)

Main Street: SIENNA\_PKWY Cross Street: KYLE\_CT Location: NW

ADA ID: RPRK211101114532 Ramp Type: Type 1 - Perpendicular Initial Pass/Fail: Fail Overall Compliance: No Severity Score: 16

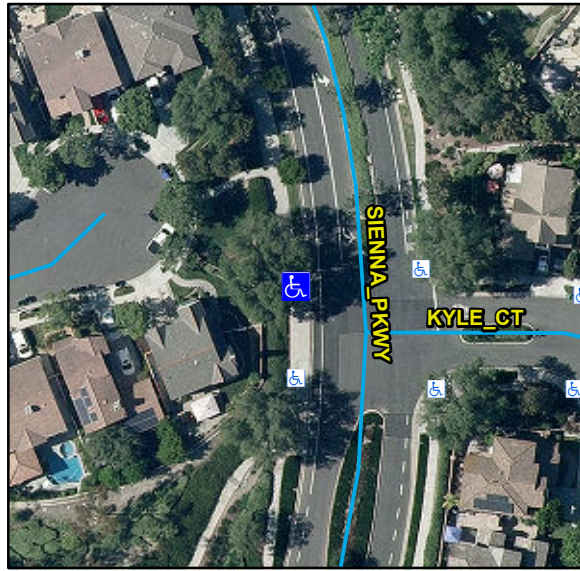
| Compliance | Description | Data | Compliance | Description | Data |
|---|---|---|---|---|---|
| No | Ramp Run Slope (%) | 8.9 | N/A | Flare Slope LT (%) | N/A |
| N/A | Gutter Ponding | N/A | No | Curb Slope | 11.6 |

Remove & Replace Entire Ramp.

R304.2.2, R204.3, STD 1115

Total Cost: \$ 3080
