# Access Compliance Report Public Rights-of-Way (Curb Ramps)

Main Street: KYLE\_CT Cross Street: KYLE\_CT Location: W

ADA ID: RPRK211101114810 Ramp Type: Type 4 - Parallel Initial Pass/Fail: Fail Overall Compliance: No Severity Score: 20

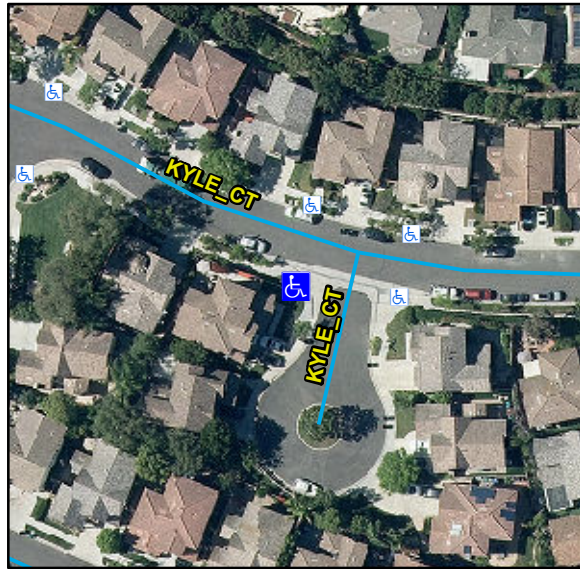
| Compliance | Description | Data | Compliance | Description | Data |
|---|---|---|---|---|---|
| Yes | Ramp Width LT (in) | 54 | No | Ramp Width RT (in) | 44 |
| Yes | Ramp Run Slope LT (%) | 3.4 | No | Ramp Run Slope RT (%) | 9.9 |
| No | Ramp Cross Slope LT (%) | 2.6 | Yes | Ramp Cross Slope RT (%) | 1.3 |

Remove & Replace Curb Ramp With Two New Directional Ramps or Equivalent.

R304.5.1, R304.5.3, R304.3.2, STD 1115
