# Access Compliance Report Public Rights-of-Way (Curb Ramps)

Main Street: KYLE\_CT Cross Street: KYLE\_CT Location: S

ADA ID: RPRK211101115007 Ramp Type: Type 4 - Parallel Initial Pass/Fail: Fail Overall Compliance: No Severity Score: 15

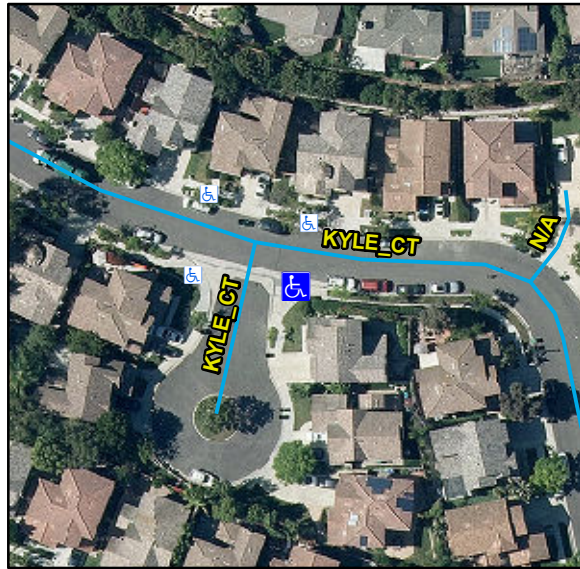
| Compliance | Description | Data | Compliance | Description | Data |
|---|---|---|---|---|---|
| No | Ramp Run Slope LT (%) | 9.4 | Yes | Ramp Run Slope RT (%) | 5.1 |

Remove & Replace Curb Ramp With Two New Directional Ramps or Equivalent.

R304.3.2, STD 1115
