# Access Compliance Report Public Rights-of-Way (Curb Ramps)

| Main Street: CROWN_VALLEY_PKWY | | Cross Street: SIENNA_PKWY | | Location: | S |
| ADA ID: RPRK211101115954 | Ramp Type:Type 1 - Perpendicular Diagonal Initial Pass/Fail: Fail | | Overall Compliance: No | Severity Score: | 15 |

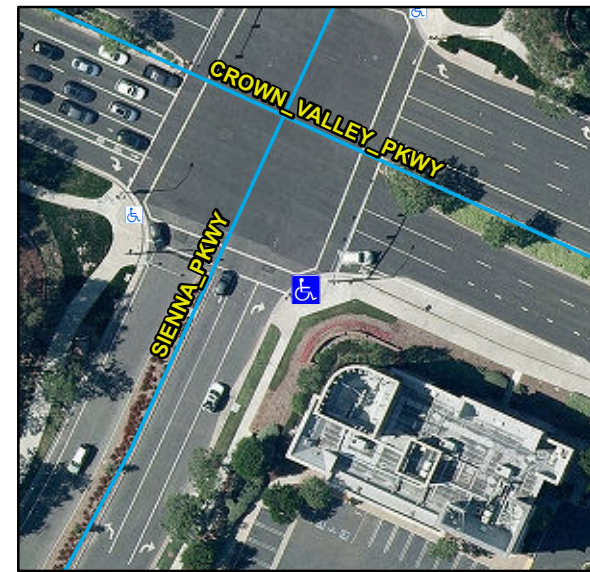
**R304.2.2, R204.3, R304.5.3, STD 1115**

**Remove & Replace Curb Ramp With Two New Directional Ramps or Equivalent.**

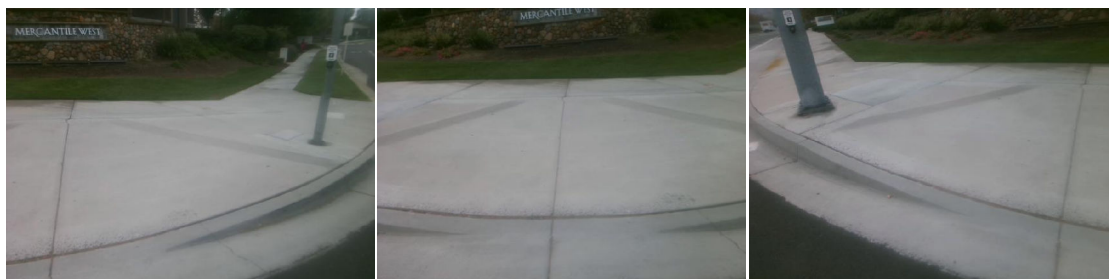
| Compliance | Description | Data | Compliance | Description | Data |
|---|---|---|---|---|---|
| Yes | Ramp Width (in) | 48 | | | N/A |
| Yes | Ramp Run Slope (%) | 7.4 | N/A | Flare Slope LT (%) | N/A |
| No | Ramp Cross Slope (%) | 5.5 | N/A | Flare Traversable LT | N/A |
