# Access Compliance Report Public Rights-of-Way (Curb Ramps)

Main Street: N/A Cross Street: CROWN\_VALLEY\_PKWY Location: W

ADA ID: RPRK211101120142 Ramp Type: Type 1 - Perpendicular Diagonal Initial Pass/Fail: Fail Overall Compliance: No Severity Score: 2

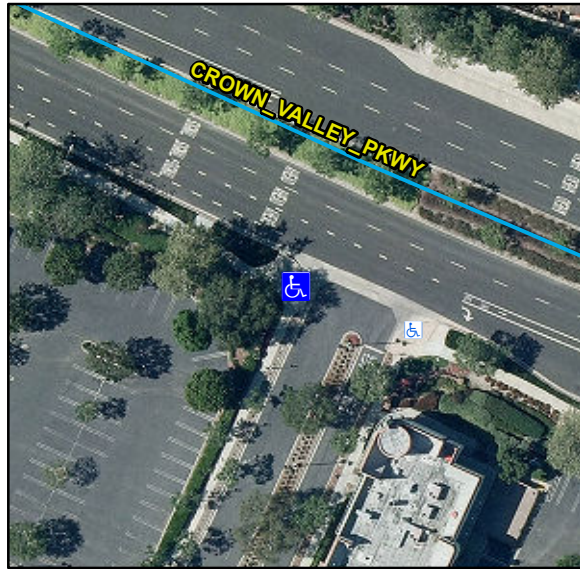
| Compliance | Description | Data | Compliance | Description | Data |
|---|---|---|---|---|---|
| No | Ramp Cross Slope (%) | 3.4 | N/A | Flare Traversable LT | N/A |

Remove & Replace Curb Ramp With Two New Directional Ramps or Equivalent.

R204.3, R304.5.3, STD 1115
