# Access Compliance Report Public Rights-of-Way (Curb Ramps)

Main Street: N/A Cross Street: CROWN\_VALLEY\_PKWY Location: W

ADA ID: RPRK211101120409 Ramp Type: Type 1 - Perpendicular Diagonal Initial Pass/Fail: Fail Overall Compliance: No Severity Score: 15

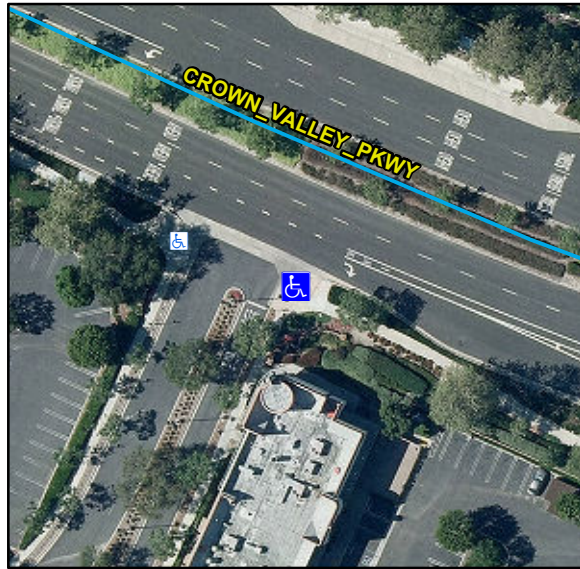
| Compliance | Description | Data | Compliance | Description | Data |
|---|---|---|---|---|---|
| No | Ramp Run Slope (%) | 8.7 | N/A | Flare Slope LT (%) | N/A |

**Remove & Replace Curb Ramp With Two New Directional Ramps or Equivalent.**

**R304.2.2, R204.3, STD 1115**
