Access Compliance Report Public Rights-of-Way (Curb Ramps)

Main Street: **ANTONIO_PKWY** Cross Street: **CROWN_VALLEY_PKWY** Location: **SW**

ADA ID: **RPRK211101120832** Ramp Type: **Type 1 - Perpendicular Diagonal Initial Pass/Fail: Pass** Overall Compliance: **Yes** Severity Score: **0**

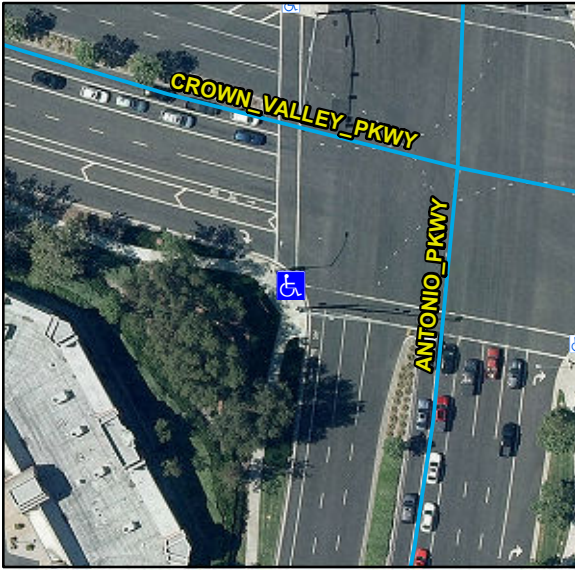
Compliance	Description	Data	Compliance	Description	Data
N/A	Ramp Length (in)	128	N/A	Flare Type LT	
Yes	Ramp Width (in)	48			Sloped
Yes	Ramp Run Slope (%)	5.4	N/A	Flare Slope LT (%)	4.9
Yes	Ramp Cross Slope (%)	0	N/A	Flare Traversable LT	No
N/A	Landing Present	Yes	N/A	Flare Type RT	
N/A	Landing Length (in)	60			Sloped
Yes	Landing Width (in)	48	Yes	Flare Slope RT (%)	3.6
Yes	Landing Run Slope (%)	0.3	N/A	Flare Traversable RT	Yes
Yes	Landing Cross Slope (%)	1.4	Yes	DWS Provided	Yes
N/A	Landing Movement Obstructed?	No	Yes	DWS Contrast	Yes
	Landing Movement Type	N/A	Yes	DWS Length (in)	36
N/A	Landing Shared	No	Yes	DWS Full Width	Yes
Yes	Clear Space	Yes	Yes	DWS Offset Left (in)	0
Yes	Clear Space To Crosswalk (in)	48	Yes	DWS Offset Right (in)	N/A
N/A	Marked Crosswalk 1	Yes	N/A	Marked Crosswalk 2	Yes
	Crossing 1 Direction	SE		Crossing 2 Direction	NE
	Marked Crosswalk 1 Width (in)	144		Marked Crosswalk 2 Width (in)	144

Yes	Ramp Inside Crosswalk 1	Yes	Yes	Ramp Inside Crosswalk 2	Yes
	Crossing 1 Slope (%)	4.1		Crossing 2 Slope (%)	0.2
	Crossing 1 Cross Slope (%)	1.1		Crossing 2 Cross Slope (%)	3
Yes	Gutter Ponding	No	Yes	Curb Slope	3.5
Yes	Gutter Lip Height (in)	0		Road Run Slope (%)	0.8
Yes	Gutter Run Slope (%)	3.2		Road Cross Slope (%)	5.3
Yes	Gutter Cross Slope (%)	0.4			
Yes	Overall Surface Condition: Acceptable		Yes	Perp Joint Present	Yes
	Cross Gutter Present?	No		Spandrel Present?	No
	Replace Cross Gutter?	N/A		Replace Spandrel?	N/A

N/A
