# Access Compliance Report Public Rights-of-Way (Curb Ramps)

Main Street: N/A Cross Street: CROWN\_VALLEY\_PKWY Location: S

ADA ID: RPRK211101121155 Ramp Type: Type 1 - Perpendicular Diagonal Initial Pass/Fail: Fail Overall Compliance: No Severity Score: 2

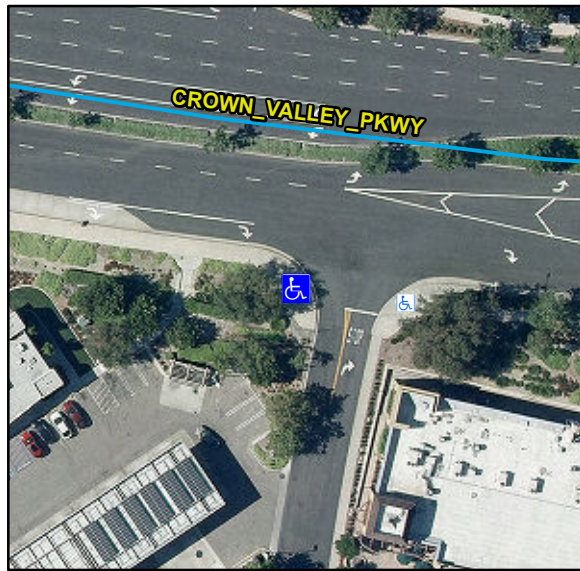
| Compliance | Description | Data | Compliance | Description | Data |
|---|---|---|---|---|---|
| No | Ramp Cross Slope (%) | 2.5 | N/A | Flare Traversable LT | N/A |

Remove & Replace Curb Ramp With Two New Directional Ramps or Equivalent.

R204.3, R304.5.3, STD 1115
