# Access Compliance Report Public Rights-of-Way (Curb Ramps)

Main Street: CROWN\_VALLEY\_PKWY Cross Street: N/A Location: S

ADA ID: RPRK211101121503 Ramp Type: Type 1 - Perpendicular Diagonal Initial Pass/Fail: Fail Overall Compliance: No Severity Score: 2

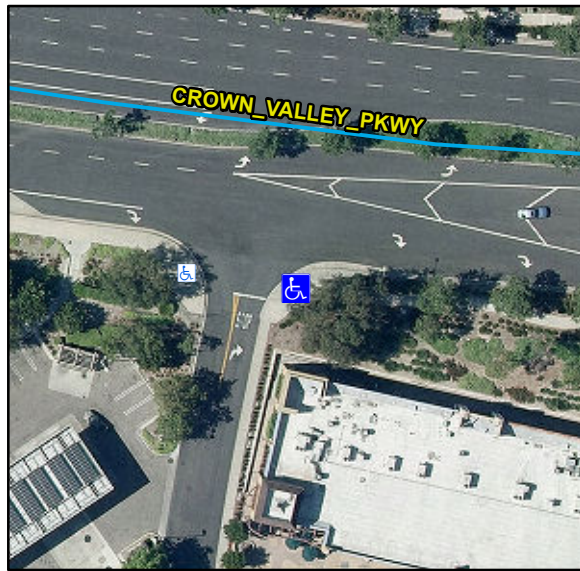
| Compliance | Description | Data | Compliance | Description | Data |
|---|---|---|---|---|---|
| No | Ramp Cross Slope (%) | 2.4 | N/A | Flare Traversable LT | N/A |

Remove & Replace Curb Ramp With Two New Directional Ramps or Equivalent.

R304.2.2, R204.3, R304.5.3, STD 1115
