# Access Compliance Report Public Rights-of-Way (Curb Ramps)

Main Street: CROWN\_VALLEY\_PKWY Cross Street: CROWN\_VALLEY\_PKWY Location: SW

ADA ID: RPRK211101121720 Ramp Type: Type 1 - Perpendicular Diagonal Initial Pass/Fail: Pass Overall Compliance: No Severity Score: 16

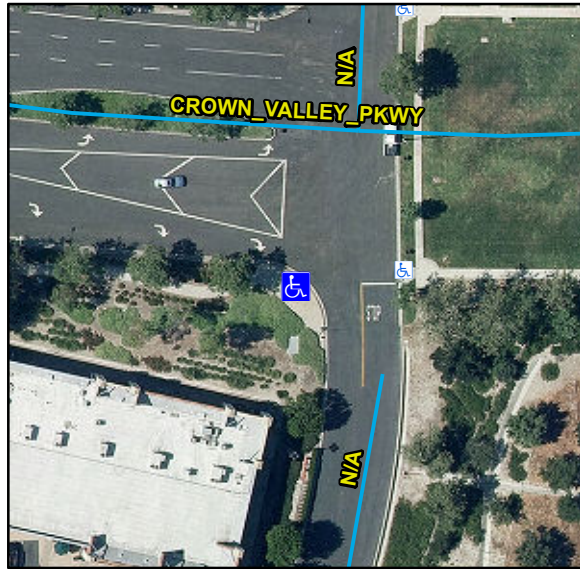
| Compliance | Description | Data | Compliance | Description | Data |
|---|---|---|---|---|---|
| No | Landing Run Slope (%) | 3.6 | N/A | Flare Traversable RT | Yes |
| Yes | Landing Cross Slope (%) | 0.2 | No | DWS Provided | No |
| Yes | Gutter Ponding | No | No | Curb Slope | 5.2 |
| No | Gutter Run Slope (%) | 5.3 | | Road Cross Slope (%) | 0.9 |

Remove & Replace Curb Ramp With Two New Directional Ramps or Equivalent. Remove & Replace Gutter.
