# Access Compliance Report Public Rights-of-Way (Curb Ramps)

Main Street: CROWN\_VALLEY\_PKWY Cross Street: CROWN\_VALLEY\_PKWY Location: S

ADA ID: RPRK211101122027 Ramp Type: Type 1 - Perpendicular Initial Pass/Fail: Fail Overall Compliance: No Severity Score: 2

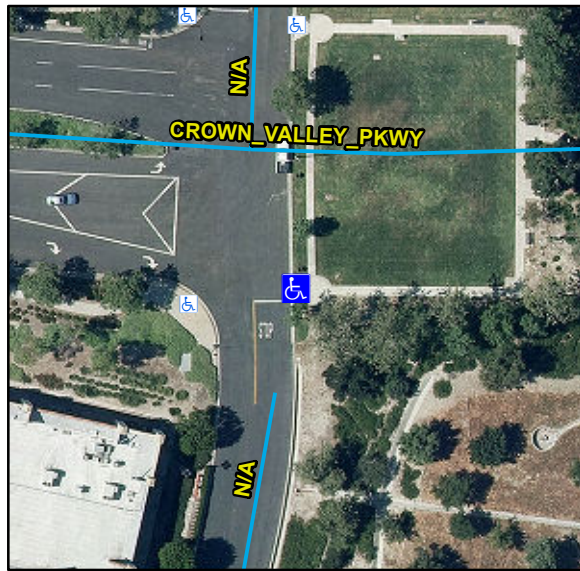
| Compliance | Description | Data | Compliance | Description | Data |
|---|---|---|---|---|---|
| No | Ramp Cross Slope (%) | 3.5 | N/A | Flare Traversable LT | N/A |

Remove & Replace Entire Ramp.

R304.2.2, R204.3, R304.5.3, STD 1115
