# Access Compliance Report Public Rights-of-Way (Curb Ramps)

Main Street: N/A Cross Street: CROWN\_VALLEY\_PKWY Location: NE

ADA ID: RPRK211101122145 Ramp Type: Type 1 - Perpendicular Initial Pass/Fail: Pass Overall Compliance: No Severity Score: 15

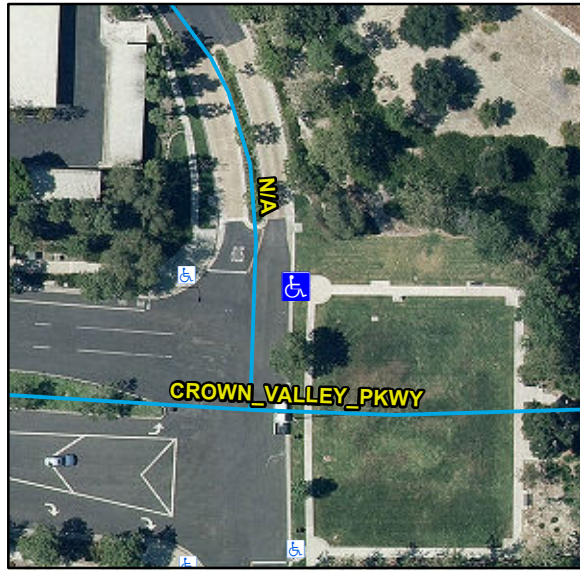
| Compliance | Description | Data | Compliance | Description | Data |
|---|---|---|---|---|---|
| Yes | Landing Cross Slope (%) | 1.2 | No | DWS Provided | No |
| Yes | Gutter Ponding | No | No | Curb Slope | 9.1 |
| No | Gutter Run Slope (%) | 9 | | Road Cross Slope (%) | N/A |

**Remove & Replace Entire Ramp. Remove & Replace Gutter.**

**R304.2.2, R305, R304.5.4, STD 1115**
