# Access Compliance Report Public Rights-of-Way (Curb Ramps)

Main Street: CROWN\_VALLEY\_PKWY Cross Street: N/A Location: NW

ADA ID: RPRK211101122355 Ramp Type: Type 1 - Perpendicular Diagonal Initial Pass/Fail: Fail Overall Compliance: No Severity Score: 2

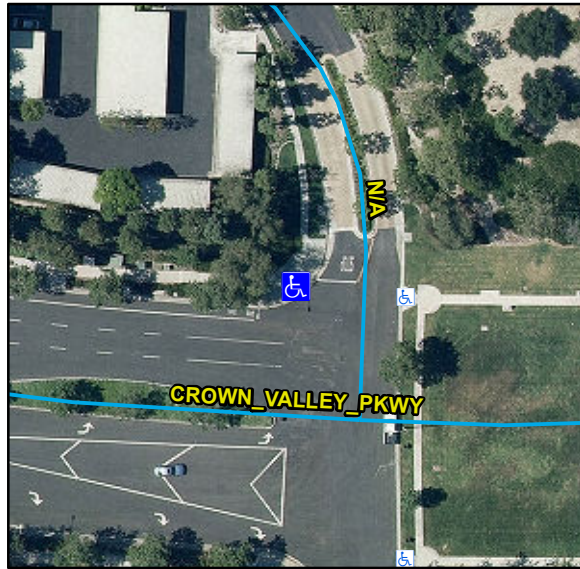
| Compliance | Description | Data | Compliance | Description | Data |
|---|---|---|---|---|---|
| No | Ramp Cross Slope (%) | 4.9 | N/A | Flare Traversable LT | N/A |

**Remove & Replace Curb Ramp With Two New Directional Ramps or Equivalent.**

**R204.3, R304.5.3, STD 1115**
