# Access Compliance Report Public Rights-of-Way (Curb Ramps)

| Main Street: RESTON_WAY | | Cross Street: MAIN_ST | | Location: | E |
| ADA ID: RPRK211101125259 | Ramp Type: Type 4 - Parallel | Initial Pass/Fail: Fail | Overall Compliance: No | Severity Score: | 32 |

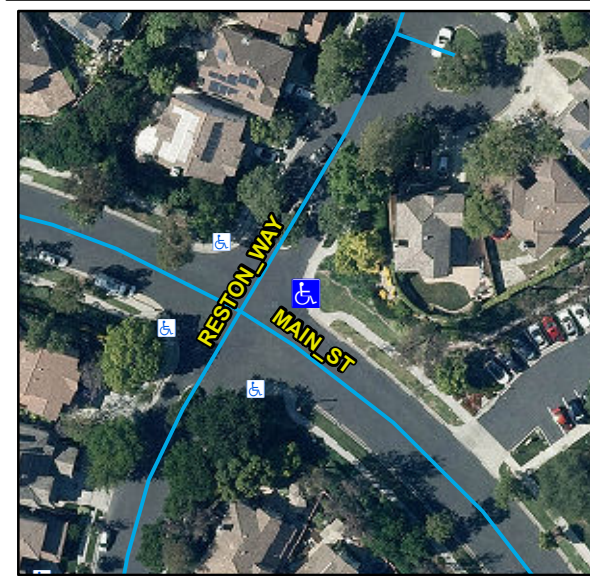
| Compliance | Description | Data | Compliance | Description | Data |
|---|---|---|---|---|---|
| No | Ramp Run Slope LT (%) | 13.2 | Yes | Ramp Run Slope RT (%) | 1 |
| Yes | Ramp Cross Slope LT (%) | 0.4 | No | Ramp Cross Slope RT (%) | 2.7 |

**Remove & Replace Curb Ramp With Two New Directional Ramps or Equivalent.**

**R204.3, R304.3.2, R304.5.3, STD 1115**

Total Cost: \$ 4000
