# Access Compliance Report Public Rights-of-Way (Curb Ramps)

| Main Street: BARNSTABLE_WAY | | Cross Street: RESTON_WAY | | Location: | S |
| ADA ID: RPRK211101125612 | Ramp Type: Type 4 - Parallel | Initial Pass/Fail: Fail | Overall Compliance: No | Severity Score: | 20 |

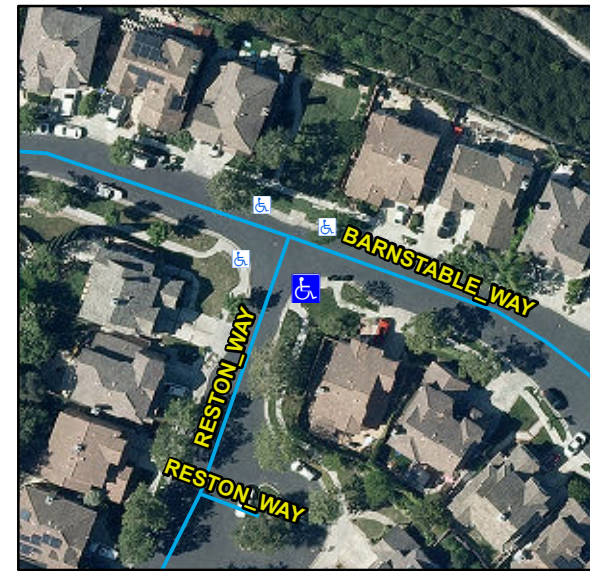
| Compliance | Description | Data | Compliance | Description | Data |
|---|---|---|---|---|---|
| No | Ramp Width LT (in) | 47 | No | Ramp Width RT (in) | 47 |
| No | Ramp Run Slope LT (%) | 10.5 | Yes | Ramp Run Slope RT (%) | 2.1 |
| No | Ramp Cross Slope LT (%) | 2.8 | Yes | Ramp Cross Slope RT (%) | 1.3 |

**Remove & Replace Curb Ramp With Two New Directional Ramps or Equivalent.**

**R204.3, R304.5.1, R304.3.2, R304.5.3, STD 1115**

Total Cost: \$ 4000
