# Access Compliance Report Public Rights-of-Way (Curb Ramps)

Main Street: RESTON\_WAY Cross Street: BARNSTABLE\_WAY Location: W

ADA ID: RPRK211101125916 Ramp Type: Type 4 - Parallel Initial Pass/Fail: Fail Overall Compliance: No Severity Score: 16

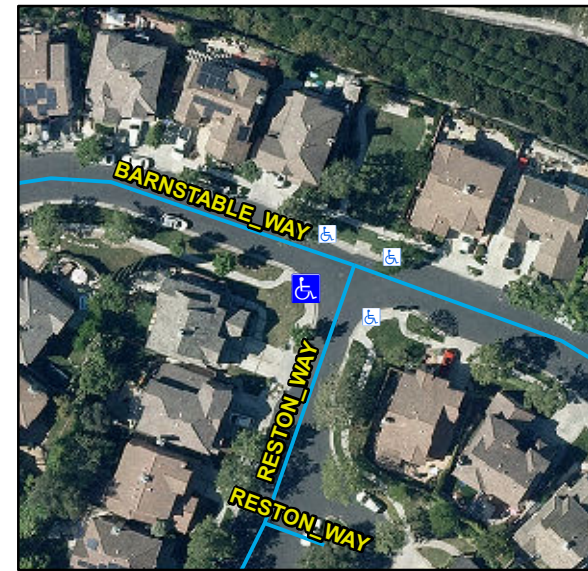
| Compliance | Description | Data | Compliance | Description | Data |
|---|---|---|---|---|---|
| Yes | Ramp Run Slope LT (%) | 3.6 | No | Ramp Run Slope RT (%) | 11.8 |
| No | Ramp Cross Slope LT (%) | 2.6 | Yes | Ramp Cross Slope RT (%) | 0.8 |

Remove & Replace Curb Ramp With Two New Directional Ramps or Equivalent.

R204.3, R304.5.3, R304.3.2, STD 1115
