# Access Compliance Report Public Rights-of-Way (Curb Ramps)

Main Street: MAIN\_ST Cross Street: RESTON\_WAY Location: N

ADA ID: RPRK211101130147 Ramp Type: Type 4 - Parallel Initial Pass/Fail: Fail Overall Compliance: No Severity Score: 32

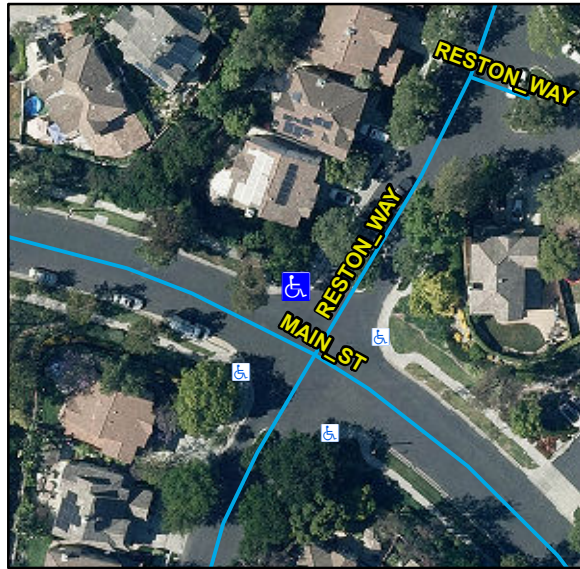
| Compliance | Description | Data | Compliance | Description | Data |
|---|---|---|---|---|---|
| No | Ramp Run Slope LT (%) | 14.3 | Yes | Ramp Run Slope RT (%) | 1.6 |

**Remove & Replace Curb Ramp With Two New Directional Ramps or Equivalent.**

**R204.3, R304.3.2, STD 1115**
