# Access Compliance Report Public Rights-of-Way (Curb Ramps)

Main Street: MAIN\_ST Cross Street: RESTON\_WAY Location: S

ADA ID: RPRK211101130351 Ramp Type: Type 4 - Parallel Initial Pass/Fail: Fail Overall Compliance: No Severity Score: 32

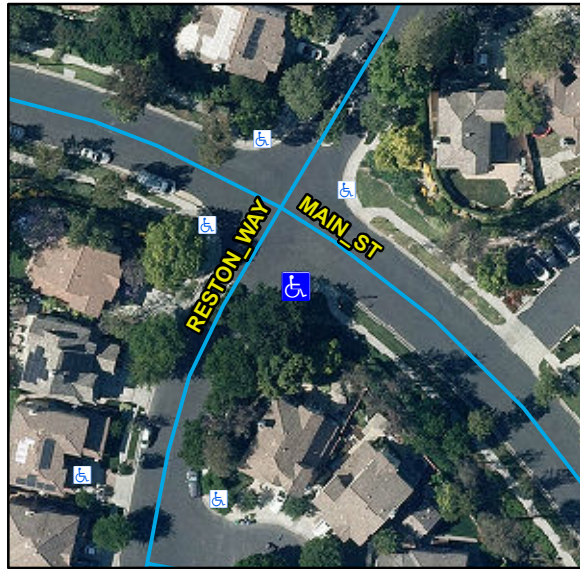
| Compliance | Description | Data | Compliance | Description | Data |
|---|---|---|---|---|---|
| Yes | Ramp Run Slope LT (%) | 1.8 | No | Ramp Run Slope RT (%) | 12.3 |
| No | Ramp Cross Slope LT (%) | 2.6 | Yes | Ramp Cross Slope RT (%) | 0.3 |
| N/A | Gutter Cross Slope (%) | N/A | No | Perpendicular Joint Present | No |

**Remove & Replace Curb Ramp With Two New Directional Ramps or Equivalent.**

**R204.3, R304.5.3, R304.3.2, STD 1115**

Total Cost: \$ 4000
