# Access Compliance Report Public Rights-of-Way (Curb Ramps)

Main Street: RESTON\_WAY Cross Street: RESTON\_WAY Location: S

ADA ID: RPRK211101130820 Ramp Type: Type 4 - Parallel Initial Pass/Fail: Fail Overall Compliance: No Severity Score: 15

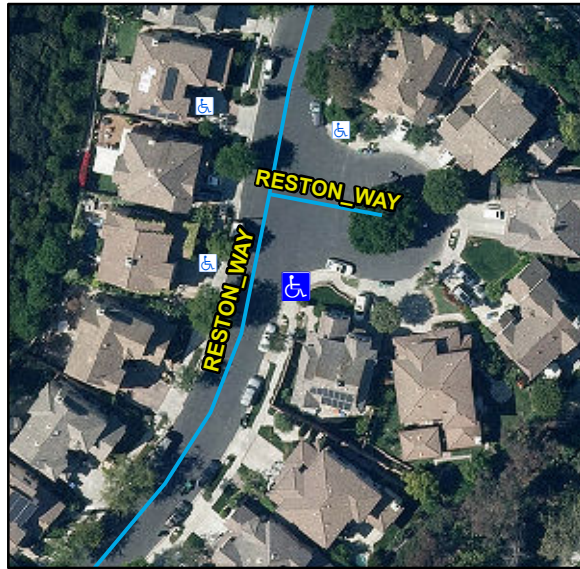
| Compliance | Description | Data | Compliance | Description | Data |
|---|---|---|---|---|---|
| Yes | Ramp Run Slope LT (%) | 4.1 | No | Ramp Run Slope RT (%) | 8.4 |

**Remove & Replace Curb Ramp With Two New Directional Ramps or Equivalent.**

**R304.3.2, STD 1115**
