# Access Compliance Report Public Rights-of-Way (Curb Ramps)

Main Street: **RESTON\_WAY** Cross Street: **MAIN\_ST** Location: **W**

ADA ID: **RPRK211101131134** Ramp Type: **Type 4 - Parallel** Initial Pass/Fail: **Fail** Overall Compliance: **No** Severity Score: **32**

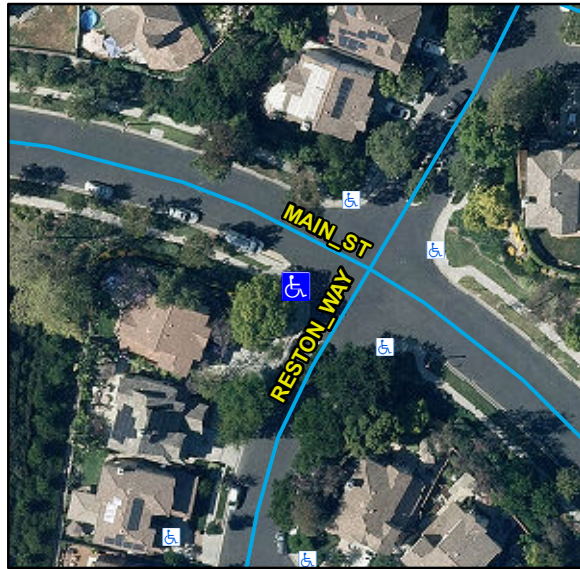
| Compliance | Description | Data | Compliance | Description | Data |
|---|---|---|---|---|---|
| <b>Yes</b> | Ramp Run Slope LT (%) | <b>3.2</b> | <b>No</b> | Ramp Run Slope RT (%) | <b>13.1</b> |
| <b>No</b> | Ramp Cross Slope LT (%) | <b>3.1</b> | <b>Yes</b> | Ramp Cross Slope RT (%) | <b>0.5</b> |

**Remove & Replace Curb Ramp With Two New Directional Ramps or Equivalent.**

**R304.5.3, R304.3.2, STD 1115**
