# Access Compliance Report Public Rights-of-Way (Curb Ramps)

Main Street: MAIN\_ST Cross Street: CHIMNEY\_LN Location: SE

ADA ID: RPRK211101131514 Ramp Type: Type 4 - Parallel Initial Pass/Fail: Fail Overall Compliance: No Severity Score: 30

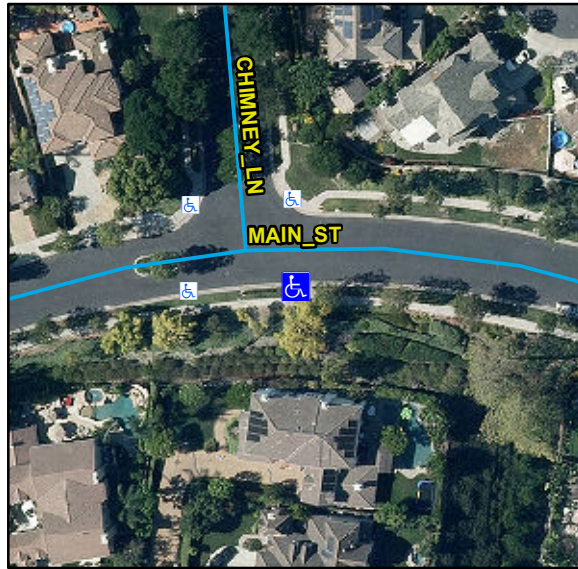
| Compliance | Description | Data | Compliance | Description | Data |
|---|---|---|---|---|---|
| No | Ramp Cross Slope LT (%) | 5.3 | No | Ramp Cross Slope RT (%) | 7.6 |

Possible Solutions:

Remove & Replace Entire Ramp.

R304.5.3, STD 1115
