# Access Compliance Report Public Rights-of-Way (Curb Ramps)

Main Street: CHIMNEY\_LN Cross Street: MAIN\_ST Location: NE

ADA ID: RPRK211101131701 Ramp Type: Type 4 - Parallel Initial Pass/Fail: Fail Overall Compliance: No Severity Score: 15

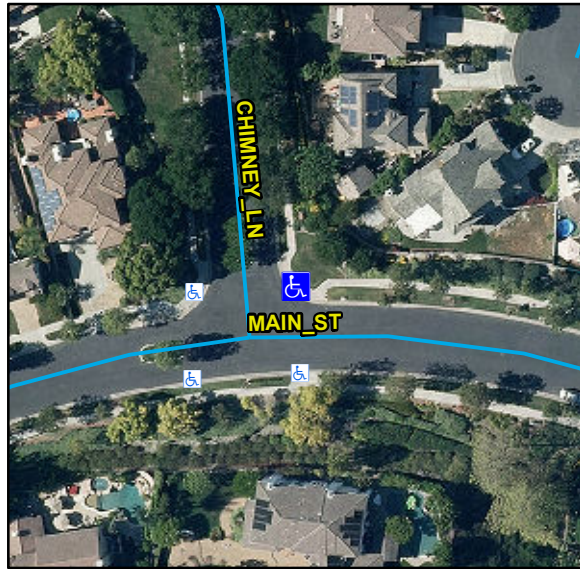
| Compliance | Description | Data | Compliance | Description | Data |
|---|---|---|---|---|---|
| No | Ramp Run Slope LT (%) | 9.6 | Yes | Ramp Run Slope RT (%) | 4.5 |

**Remove & Replace Curb Ramp With Two New Directional Ramps or Equivalent.**

**R304.3.2, STD 1115**
