# Access Compliance Report Public Rights-of-Way (Curb Ramps)

Main Street: MAIN\_ST Cross Street: CHIMNEY\_LN Location: NW

ADA ID: RPRK211101131916 Ramp Type: Type 4 - Parallel Initial Pass/Fail: Fail Overall Compliance: No Severity Score: 15

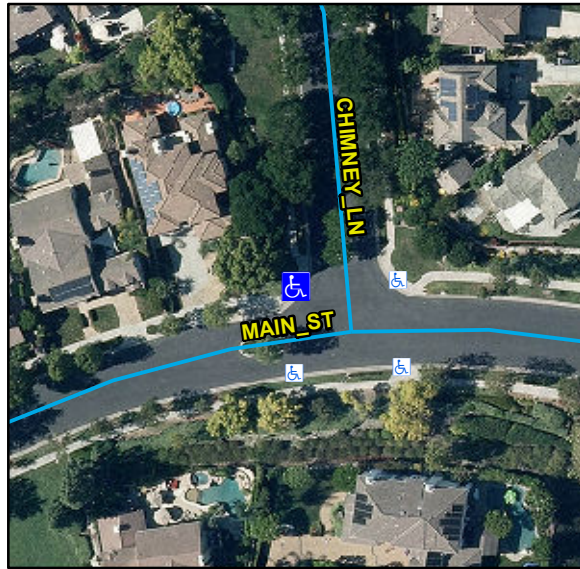
| Compliance | Description | Data | Compliance | Description | Data |
|---|---|---|---|---|---|
| No | Ramp Run Slope LT (%) | 11 | Yes | Ramp Run Slope RT (%) | 0.9 |

**Remove & Replace Curb Ramp With Two New Directional Ramps or Equivalent.**

**R204.3, R304.3.2, STD 1115**
