# Access Compliance Report Public Rights-of-Way (Curb Ramps)

Main Street: COTTAGE\_HILL\_RD Cross Street: CHIMNEY\_LN Location: E

ADA ID: RPRK211101132310 Ramp Type: Type 4 - Parallel Initial Pass/Fail: Fail Overall Compliance: No Severity Score: 32

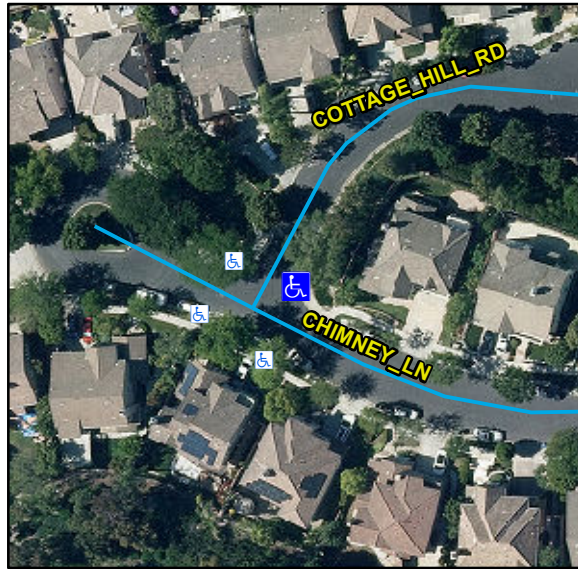
| Compliance | Description | Data | Compliance | Description | Data |
|---|---|---|---|---|---|
| Yes | Ramp Run Slope LT (%) | 0.8 | No | Ramp Run Slope RT (%) | 14.1 |
| No | Ramp Cross Slope LT (%) | 2.7 | Yes | Ramp Cross Slope RT (%) | 0.5 |

Remove & Replace Curb Ramp With Two New Directional Ramps or Equivalent.

R204.3, R304.5.3, R304.3.2, STD 1115

Total Cost: \$ 4000
