# Access Compliance Report Public Rights-of-Way (Curb Ramps)

Main Street: CHIMNEY\_LN Cross Street: COTTAGE\_HILL\_RD Location: N

ADA ID: RPRK211101132658 Ramp Type: Type 4 - Parallel Initial Pass/Fail: Pass Overall Compliance: No Severity Score: 26

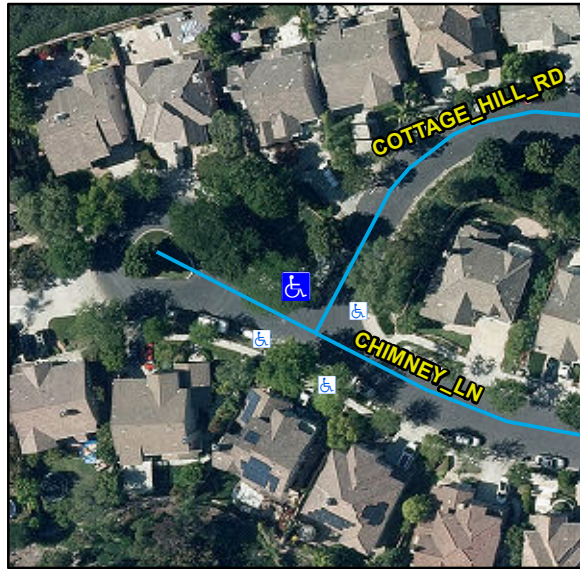
| Compliance | Description | Data | Compliance | Description | Data |
|---|---|---|---|---|---|
| No | Ramp Cross Slope LT (%) | 2.1 | Yes | Ramp Cross Slope RT (%) | 1.3 |
| No | Landing Width (in) | N/A | N/A | DWS Length (in) | N/A |
| No | Landing Run Slope (%) | N/A | N/A | DWS Full Width | N/A |
| No | Landing Cross Slope (%) | N/A | | DWS Offset Type | N/A |
| No | Gutter Run Slope (%) | 7.2 | | Road Cross Slope (%) | 0.2 |

Remove & Replace Curb Ramp With Two New Directional Ramps or Equivalent. Remove & Replace Gutter.
