# Access Compliance Report Public Rights-of-Way (Curb Ramps)

| Main Street: WELBE_CIR | | Cross Street: MAIN_ST | | Location: | SW |
| ADA ID: RPRK211101133424 | Ramp Type: Type 4 - Parallel | Initial Pass/Fail: Fail | Overall Compliance: No | Severity Score: | 16 |

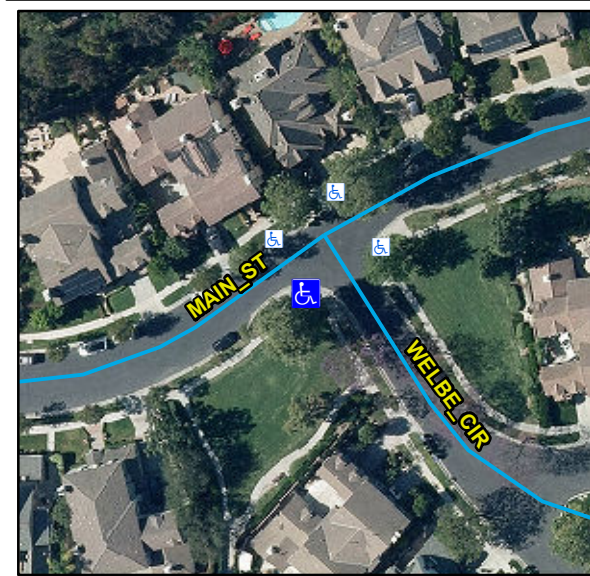
| Compliance | Description | Data | Compliance | Description | Data |
|---|---|---|---|---|---|
| Yes | Ramp Run Slope LT (%) | 1.5 | No | Ramp Run Slope RT (%) | 9.3 |
| No | Ramp Cross Slope LT (%) | 4.9 | No | Ramp Cross Slope RT (%) | 2.3 |

**Remove & Replace Curb Ramp With Two New Directional Ramps or Equivalent.**

**R204.3, R304.5.3, R304.3.2, STD 1115**
