# Access Compliance Report Public Rights-of-Way (Curb Ramps)

Main Street: MAIN\_ST Cross Street: WELBE\_CIR Location: SE

ADA ID: RPRK211101133646 Ramp Type: Type 4 - Parallel Initial Pass/Fail: Fail Overall Compliance: No Severity Score: 32

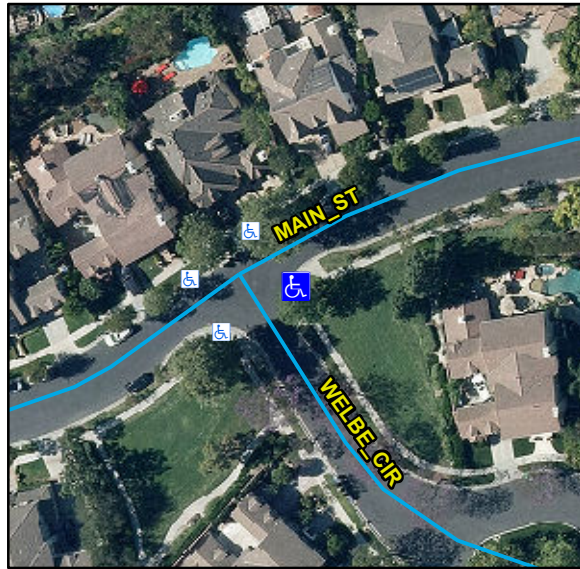
| Compliance | Description | Data | Compliance | Description | Data |
|---|---|---|---|---|---|
| Yes | Ramp Run Slope LT (%) | 1.9 | No | Ramp Run Slope RT (%) | 12.1 |
| No | Ramp Cross Slope LT (%) | 3.2 | Yes | Ramp Cross Slope RT (%) | 0.4 |

Remove & Replace Curb Ramp With Two New Directional Ramps or Equivalent.

R204.3, R304.5.3, R304.3.2, STD 1115
