# Access Compliance Report Public Rights-of-Way (Curb Ramps)

Main Street: MAIN\_ST Cross Street: N/A Location: SW

ADA ID: RPRK211102112354 Ramp Type: Type 4 - Parallel Initial Pass/Fail: Pass Overall Compliance: No Severity Score: 26

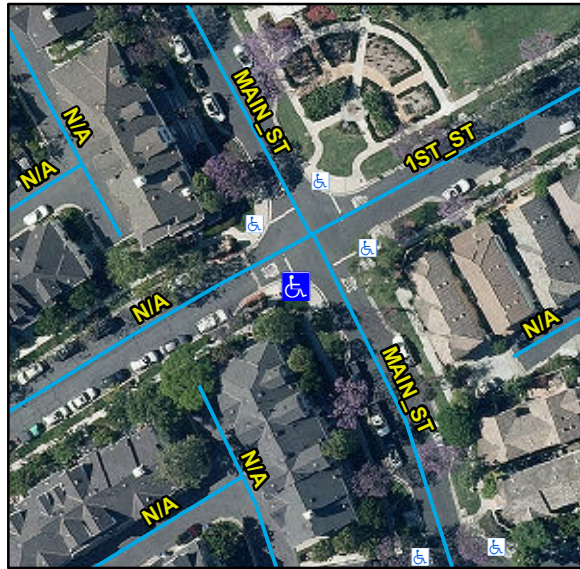
| Compliance | Description | Data | Compliance | Description | Data |
|---|---|---|---|---|---|
| N/A | Landing Present | No | No | DWS Provided | No |
| No | Landing Width (in) | N/A | N/A | DWS Length (in) | N/A |
| No | Landing Run Slope (%) | N/A | N/A | DWS Full Width | N/A |
| No | Landing Cross Slope (%) | N/A | | DWS Offset Type | N/A |
| No | Gutter Run Slope (%) | 6.7 | | Road Cross Slope (%) | 0.6 |

Remove & Replace Curb Ramp With Two New Directional Ramps or Equivalent. Remove & Replace Gutter.
